**CWA COMPLIANCE EVALUATION INSPECTION REPORT**  
**U.S. ENVIRONMENTAL PROTECTION AGENCY, REGION 5**

**Facility:** E&R Livestock  
Ex. 6 (Personal Privacy)  
[REDACTED]

**Date of Inspection:** 9/18/2013

**Report Date:** 7/1/2014

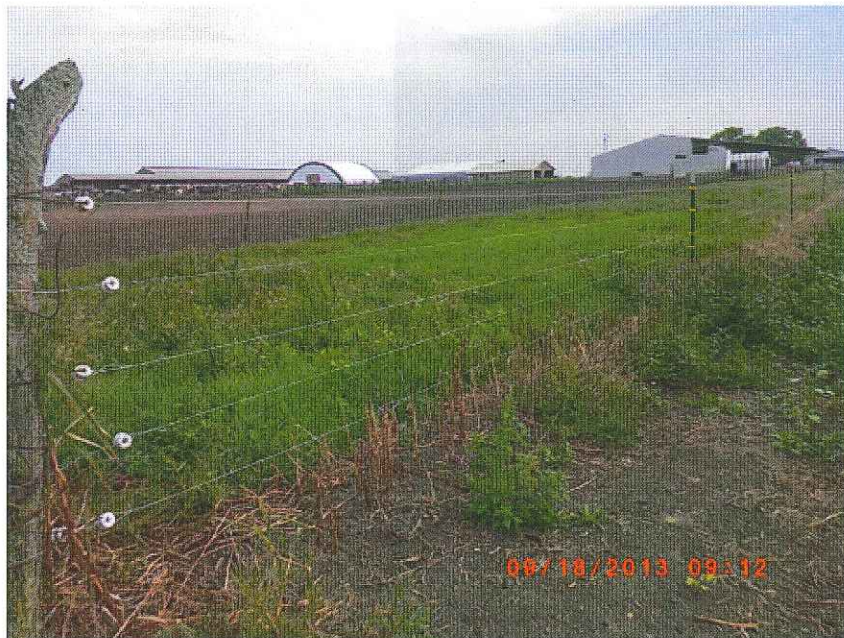
IMGP0279: Runoff from Pen 1 would flow to a vegetated field to the south.  
 Location: South of Pen 1.  
 Facing: Northwest  
 Date/Time: 09/18/13 10:09 A.M.

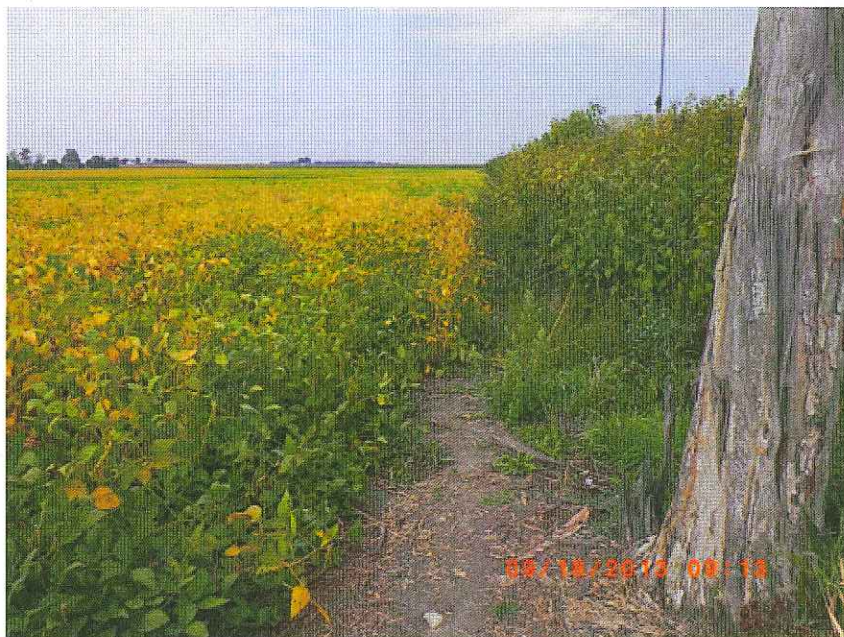
IMGP0280: Southwest corner of Pen 1. Flow off the pen would go to the west.

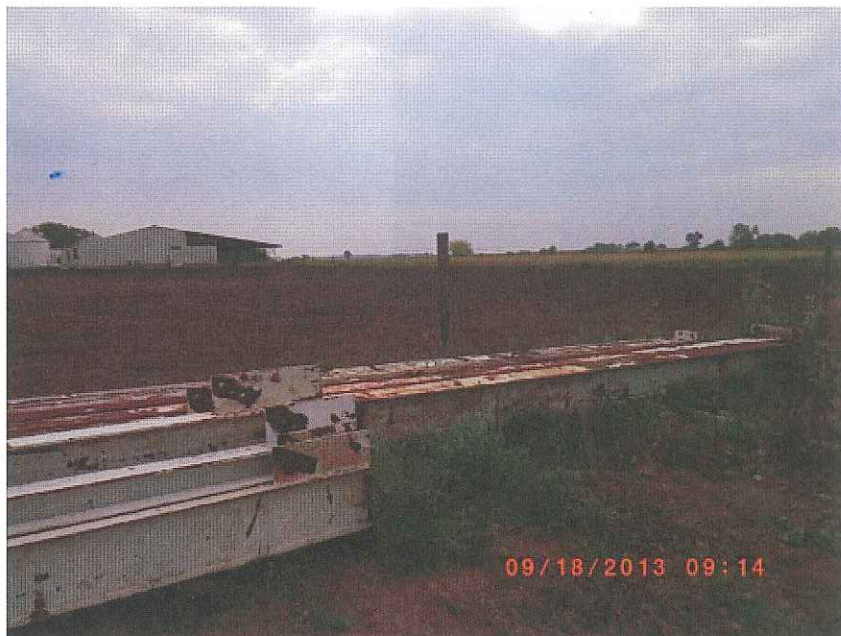
IMGP0281: Flow off of Pen 1 would flow to the west. No evidence of manure runoff into the soybean field.

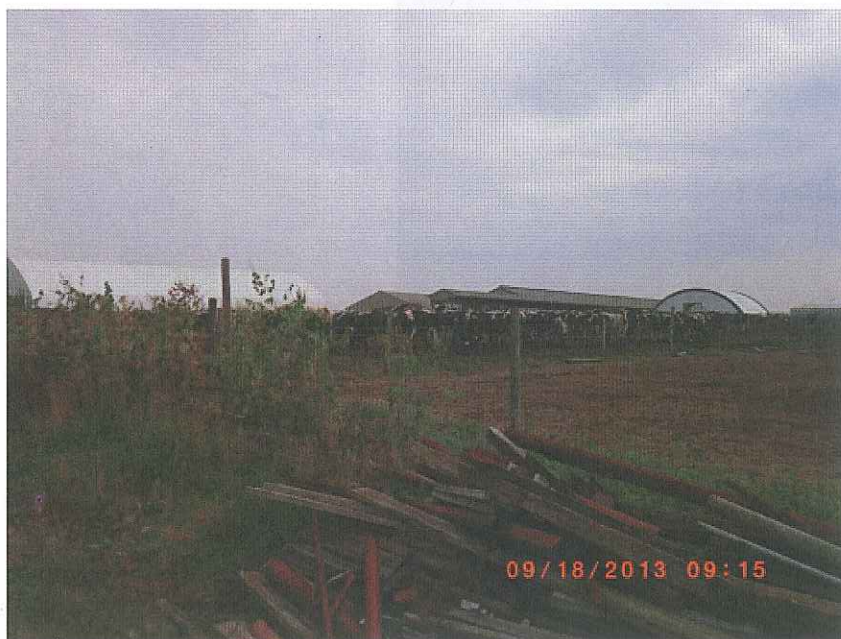
IMGP0282: Scrap metal stored along the west fence of Pen 1. No evidence of manure and process wastewater pathways from Pen 1 to waters of the U.S. on the day of the inspection.

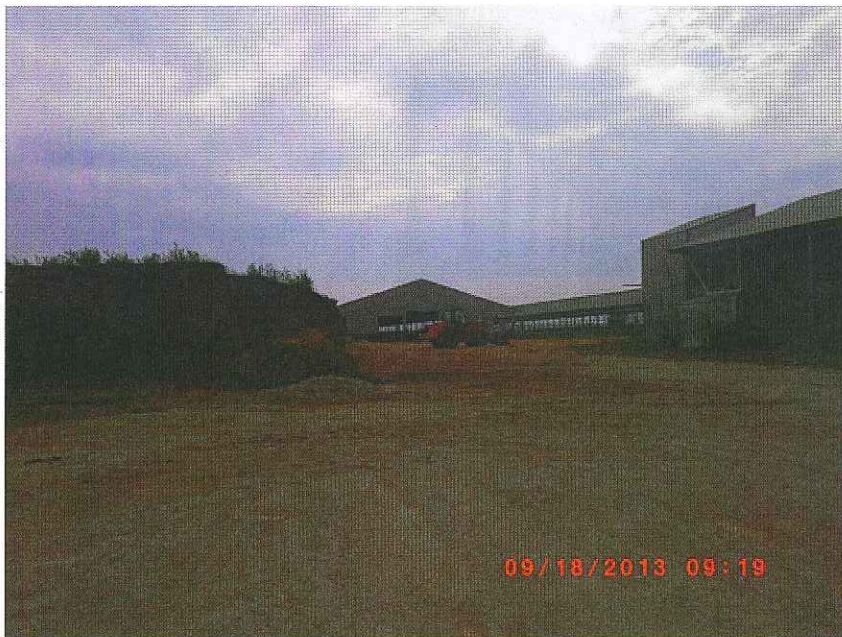
IMGP0288: Silage stacked on silage pad. Silage is not covered or in bunkers

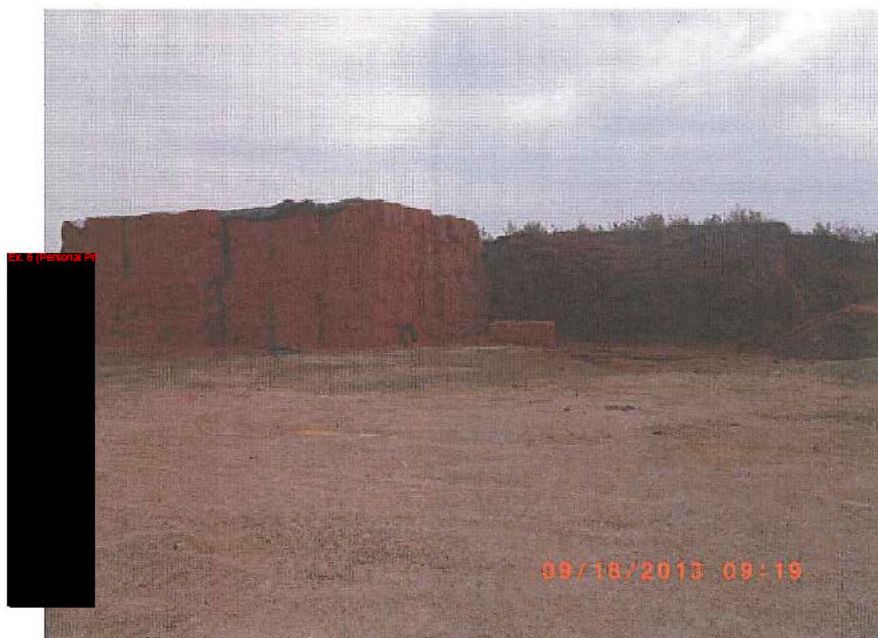
IMGP0289: Silage stacked on silage pad. Silage is not covered or in bunkers.

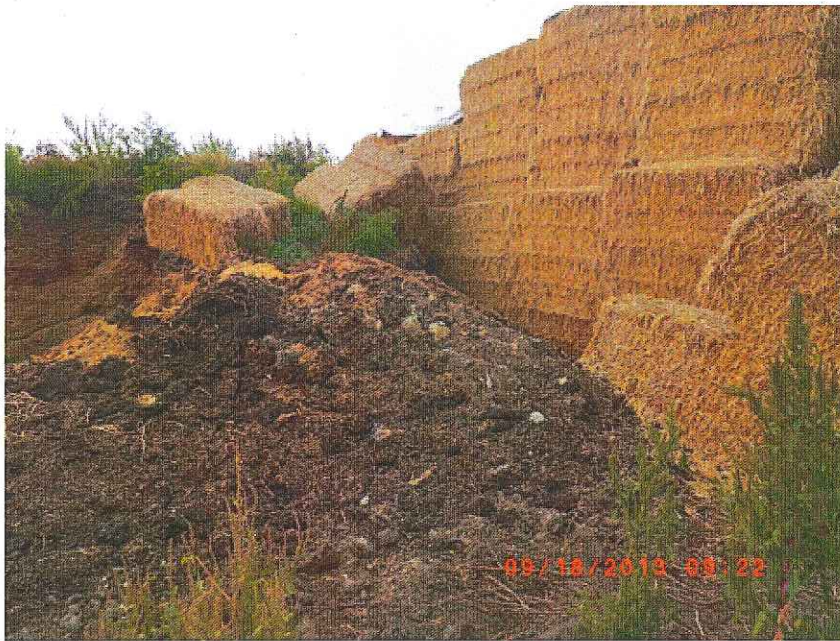
IMGP0291: Soybean field north of silage pile appears to be nutrient burned.

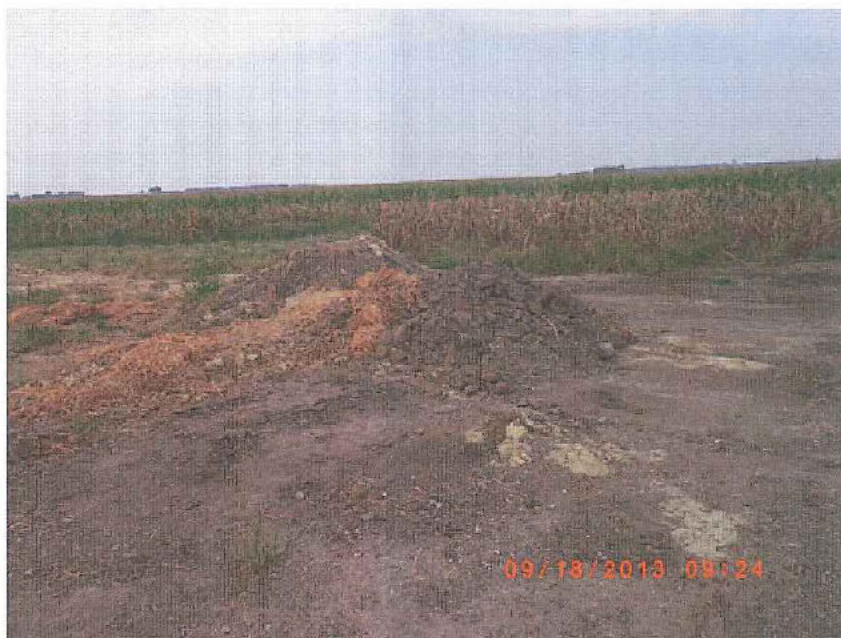
IMGP0293: Soybean field north of silage pile appears to be nutrient burned.  
 Location: North of silage pile.  
 Facing: Northeast  
 Date/Time: 09/18/13 10:22 A.M.

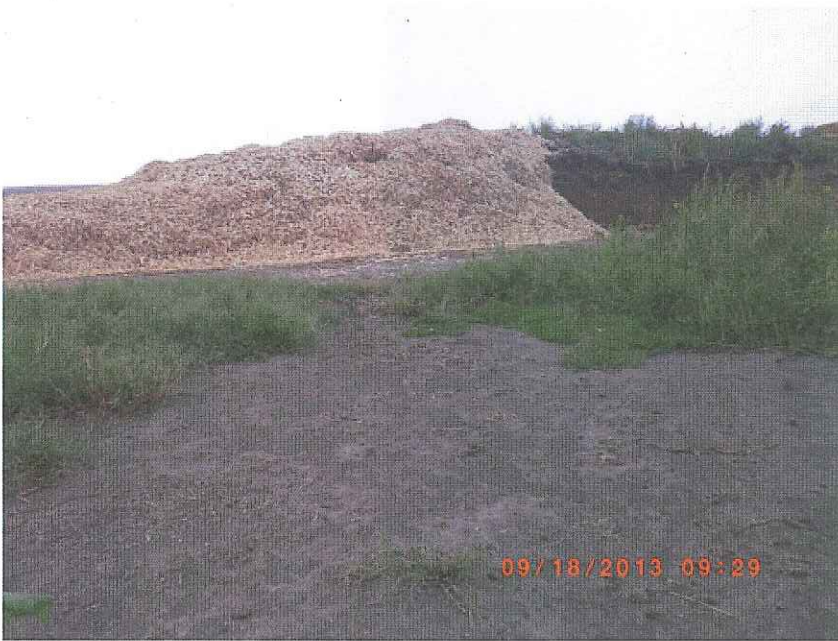
IMGP0297: Leachate from the silage pile flows to the north to a crop field. Corn shucks are also stacked in a pile in this area.

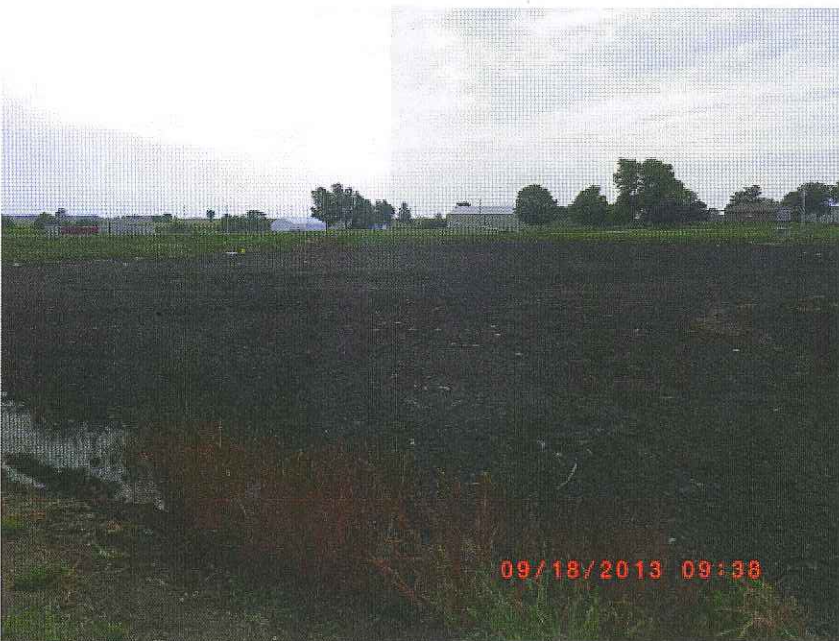
IMGP0308: Manure is pushed into Pond #1. Manure level in Pond #1 was high.

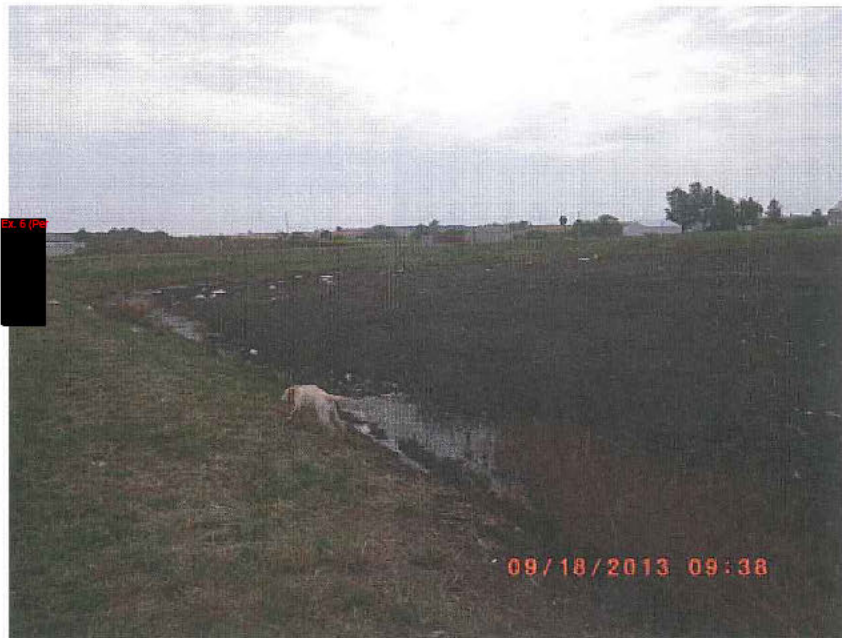
IMGP0309: Pond #1 is very full.

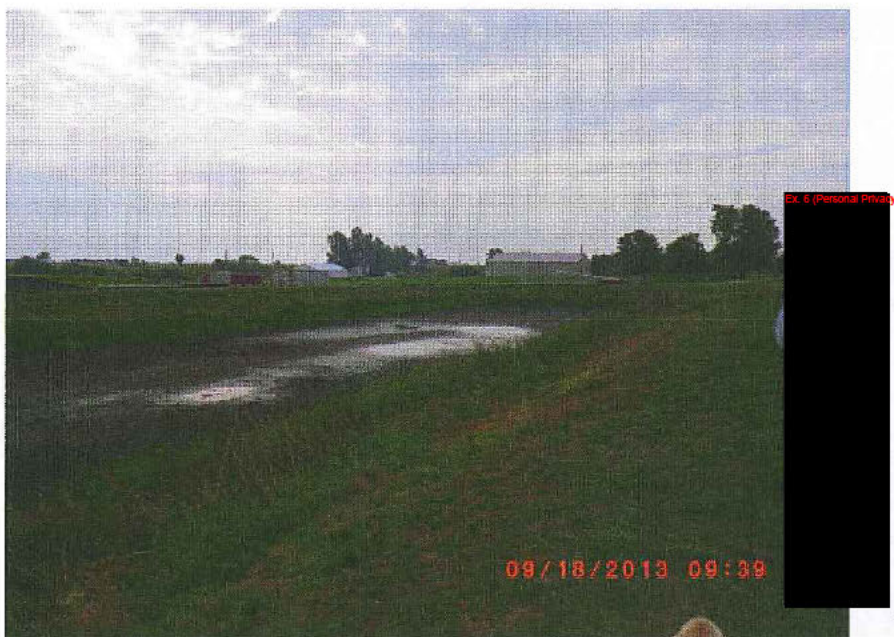
IMGP0312: Pond #2 appears to have approximately 4' of freeboard.

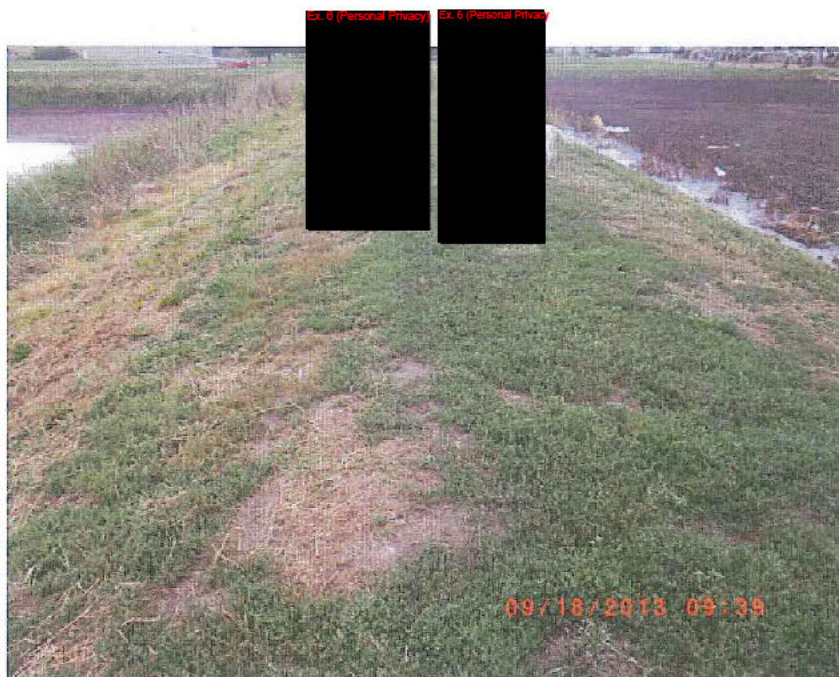
IMGP0313: Neither pond has a staff guage.

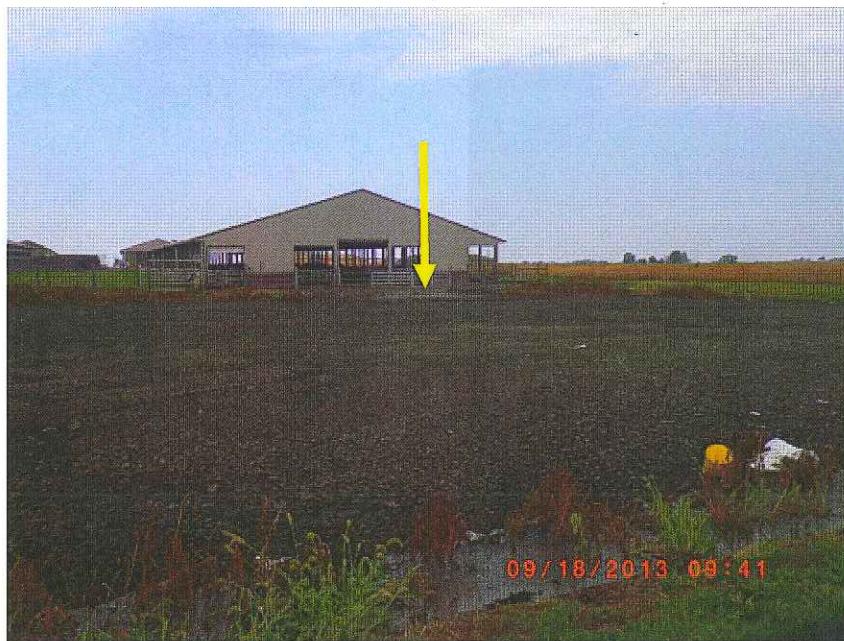
IMGP0317: Weir between Pond #1 and Pond #2. Pond #2 is in the background. Vegetation is growing in the solids that have accumulated in the bottom of the weir.

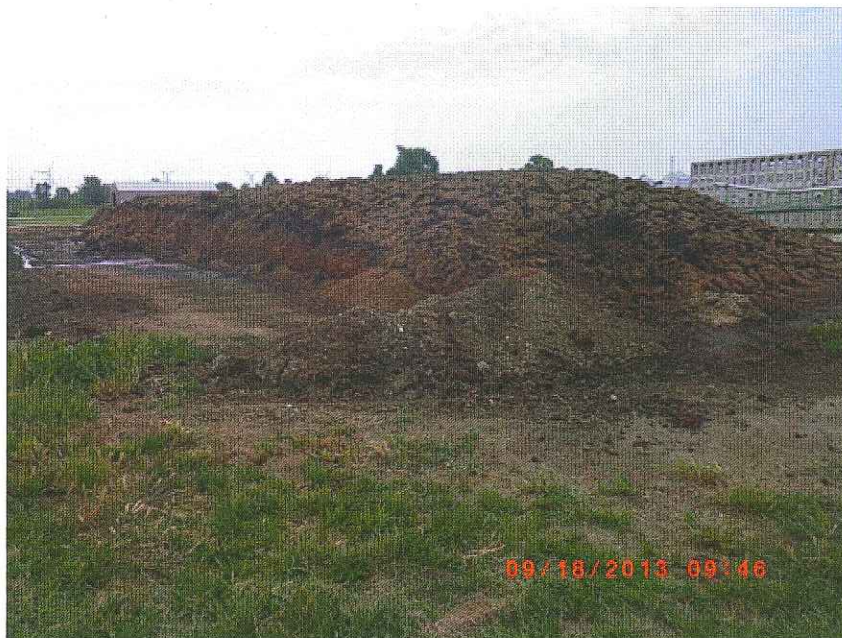
IMGP0321: Corn gluten meal pile is not covered.

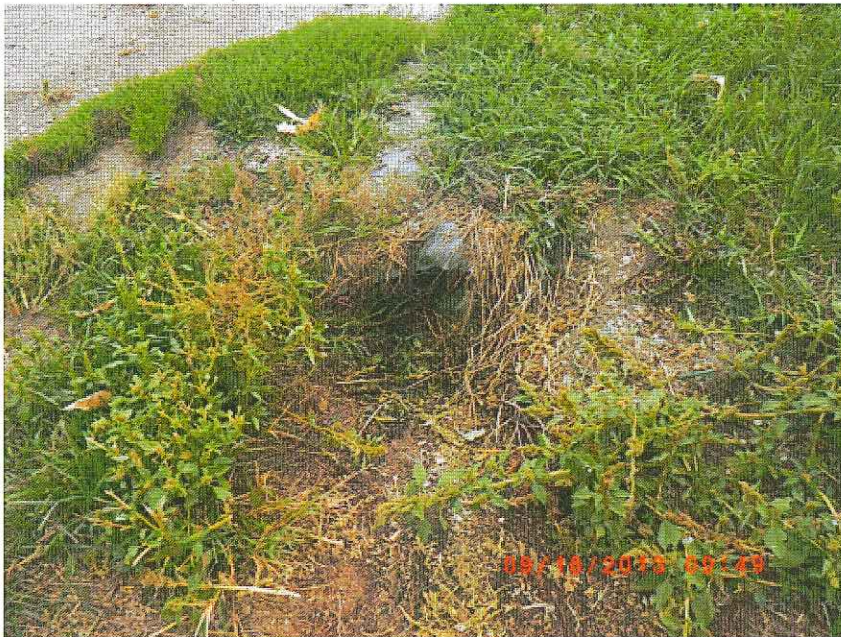
1. The corn gluten meal stored on the east side of the facility appears to have been discharging leachate and potentially solids to the roadside ditch both by leachate moving through the constructed berm and by overland flow across the driveway.
2. The corn gluten meal stored on the west side of the facility could potentially discharge leachate and solids to the inlet pipe between pens 4 and 7.

IMGP0326: Berm to prevent corn gluten meal leachate from reaching the roadside ditch has been compromised and leachate continues to flow to the ditch.

The manner in which the Corn Gluten is being stored is an apparent violation of Sections 12(a) & (d) of the Illinois Environmental Protection Act.

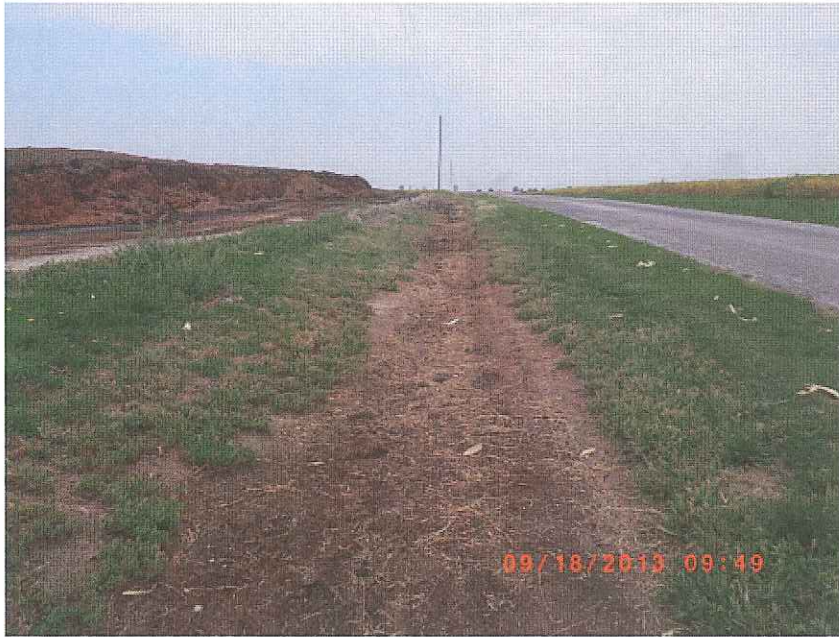
IMGP0327: A culvert allows flow from the roadside ditch, and process wastewater from the corn gluten meal pile, to flow under the facility driveway. EPA observed evidence of the process wastewater from the corn gluten meal in the roadside ditch at the entrance to the culvert.

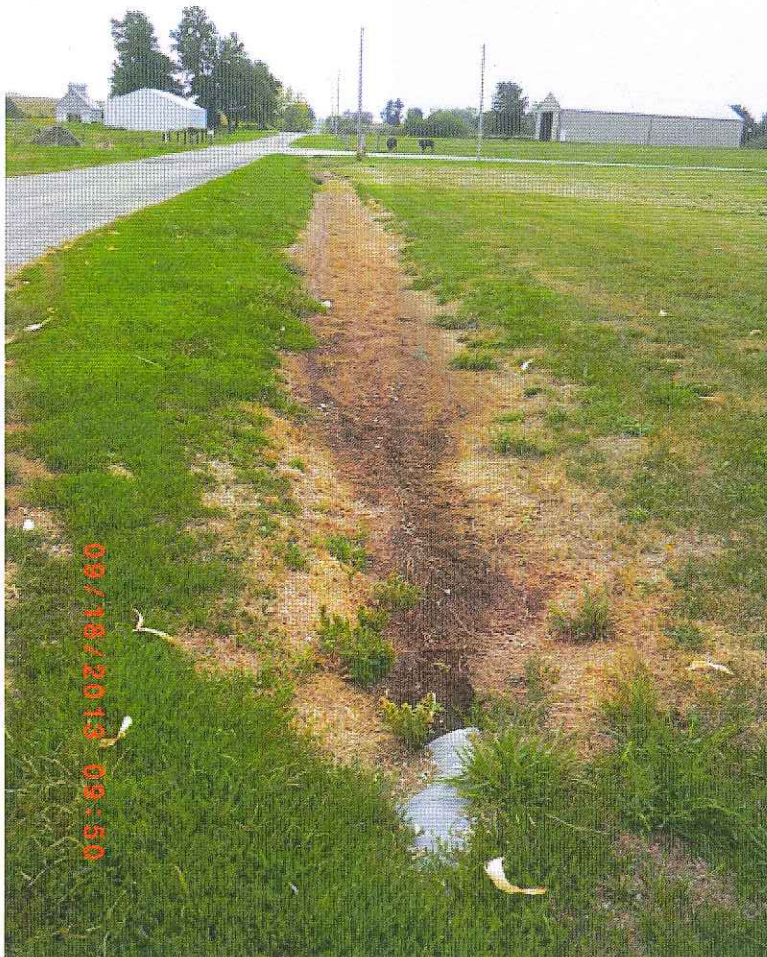
IMGP0328: Vegetation in the roadside ditch appears to be nutrient burned.

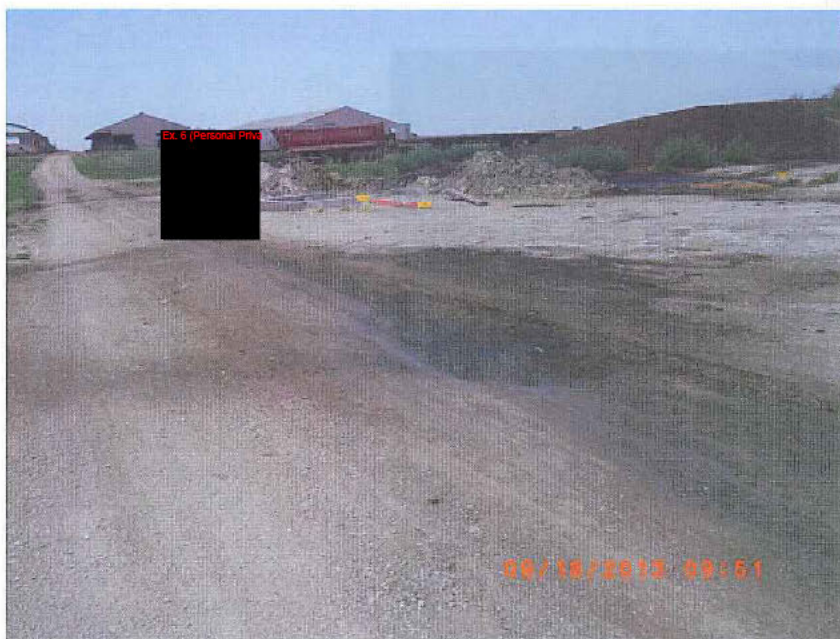
IMGP0332: Staining on the ground from the corn gluten meal leachate indicates that pathways that the process wastewater from the corn gluten meal takes.

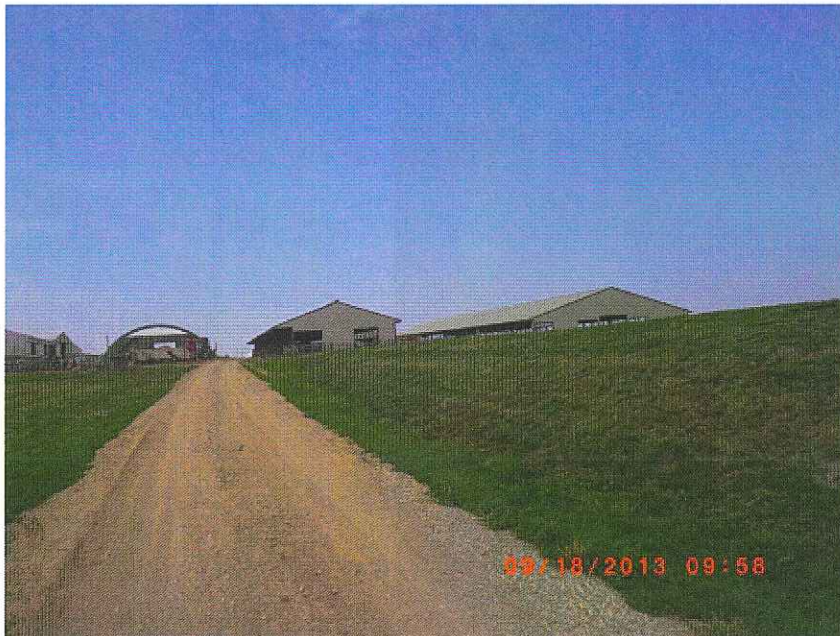
IMGP0337: Runoff pathways from corn gluten meal pile flow to the south to a vegetated yard.  
Vegetation appears nutrient burned in the yard.  
Location: Facility driveway southwest of corn gluten meal pile  
Facing: Southeast  
Date/Time: 09/18/13 10:53 A.M.

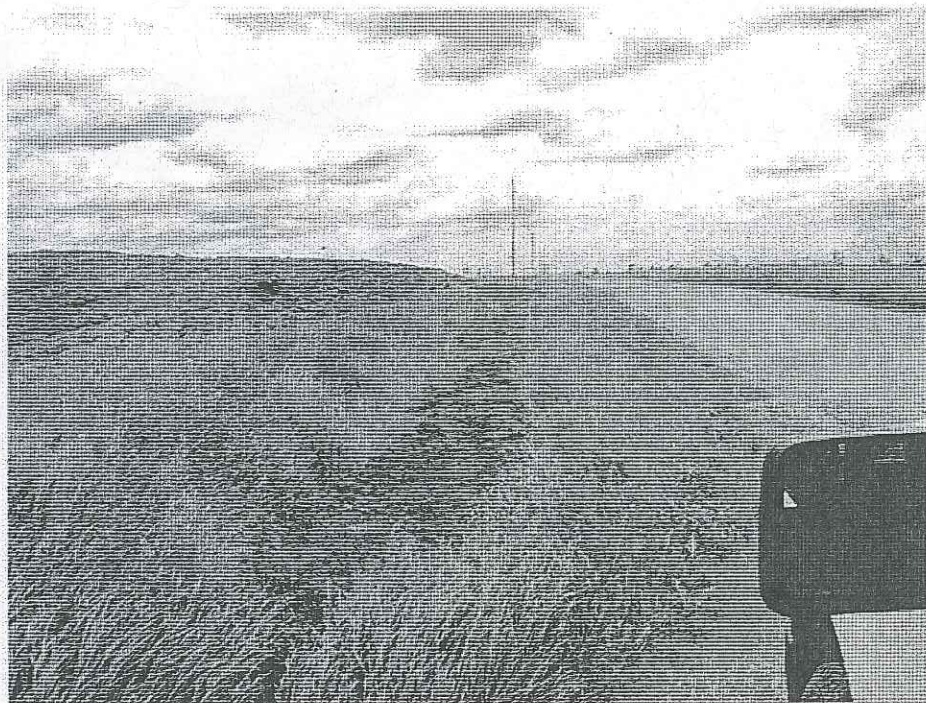
Photo #1

Photo looking north along the west ditch of 2600E Road at the north entrance to the facility. Note the dark material located in the ditch. This is corn gluten and poor quality water that has runoff from the corn gluten storage pile. This ditch is tributary to another ditch that flows into Buck Creek.

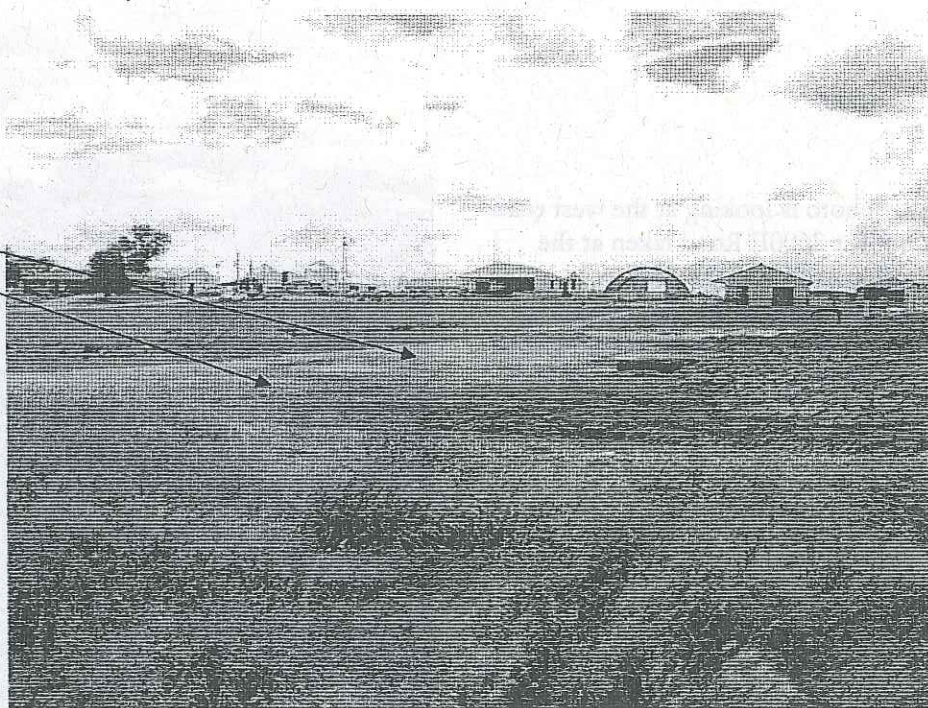
Photo #2

Photo looking at runoff from the corn gluten pile into a low area between the drives for the facility. This accumulated organic matter in a wet area tends to cause degradation of the water that collects in that low area.

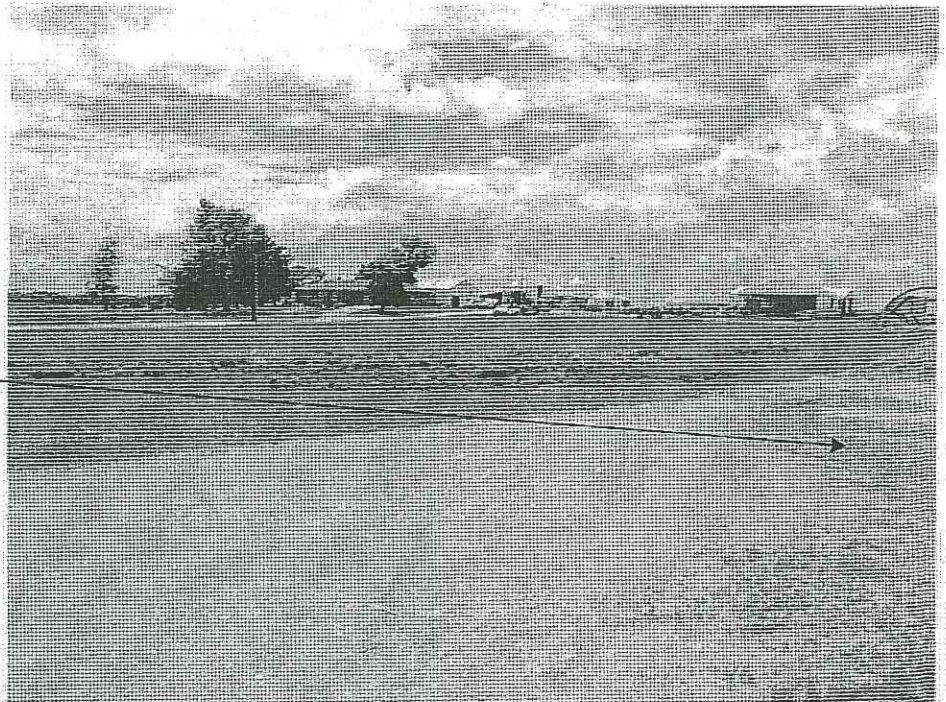
This photo shows the low area between the drives from a closer perspective. The lack of vegetation tends to indicate the standing water issue that plagues this area. Staining on the gravel drive due to runoff from the corn gluten storage piles.

Runoff from the low area flows into the road ditch and thus is tributary to Buck Creek.

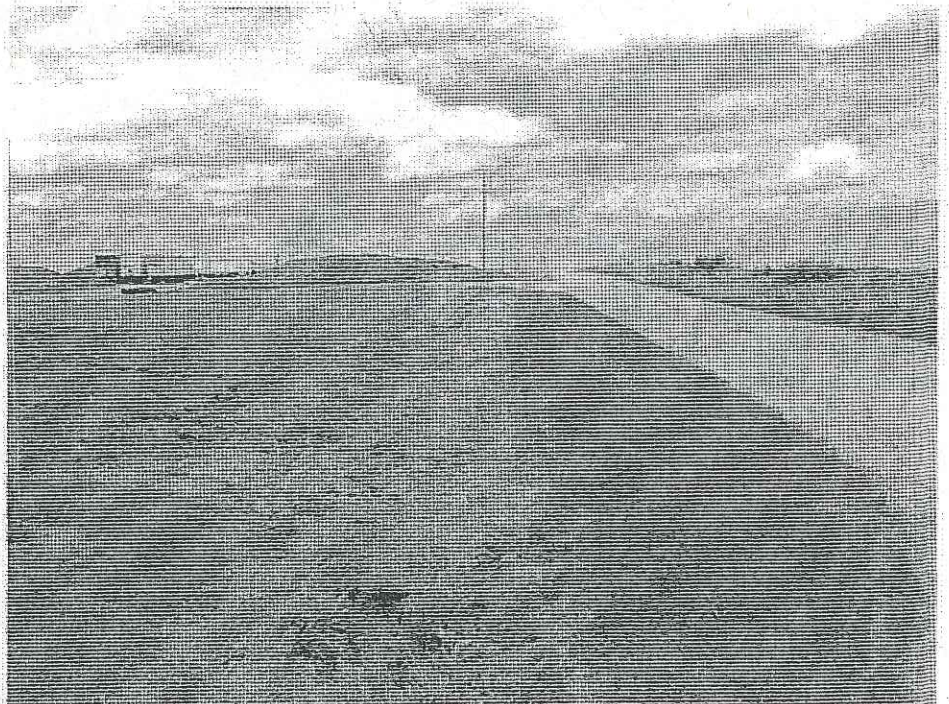
Photo #4

This photo is looking at the west road ditch for 2600E Road taken at the south entrance to the facility. The grass blown over the ditch is hiding material that has runoff from the corn gluten storage area.
